Inspection Report

Property Address:
123 W. Main
Portland, OR 97200

Carson Inspection Service

Report ID: Sample

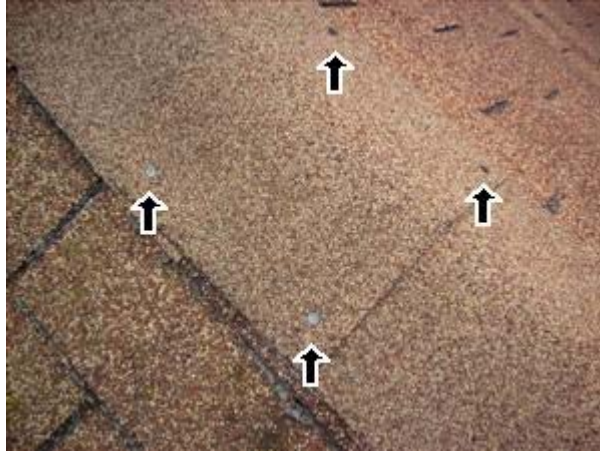
1.0 Picture 1

(1) Some exposed nailheads and staples were observed on the shingles (Picture 1) and roof vents. These nailheads may allow water to penetrate the roof surface. Recommend that all exposed nailheads and staples are sealed with a quality roof caulk.

(1) Some exposed nailheads and staples were observed on the shingles (Picture 1) and roof vents. These nailheads may allow water to penetrate the roof surface. Recommend that all exposed nailheads and staples are sealed with a quality roof caulk.
-

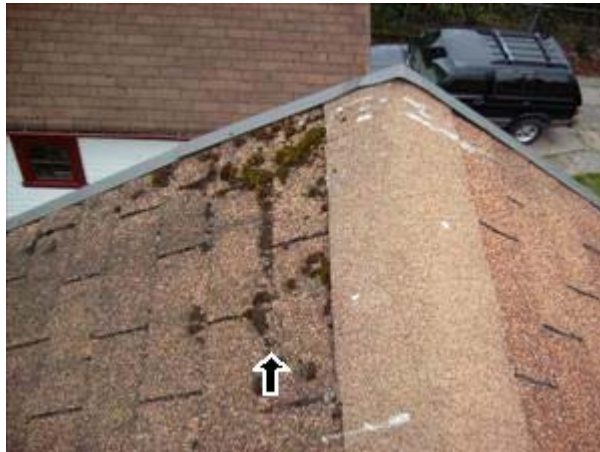
1.0 Picture 2

(2) Excess moss growth was observed at the NE end of the ridge (Picture 2) . Moss can lead to premature aging of the roof surface. Recommend that this area of the roof is treated with commercially available roof moss treatment.

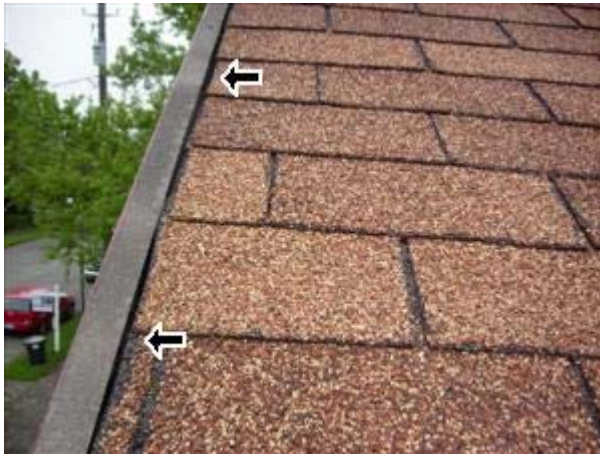
1.1 Picture 1

The roof edge flashing (L-flash) was improperly installed above the roof surface and is pulling away from the roof at the front and rear of the home (Pics1&2) . This may allow water to contact the roof sheathing. Recommend a licensed roofer repair all improperly installed flashing and failing flashing.

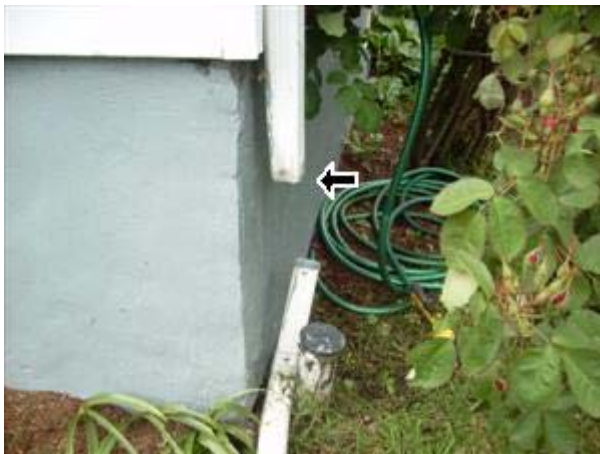
1.3 Picture 1

The downspout at the NE corner of the home had come disconnected from the diverter (Picture 1) . This can place water at the foundation wall that can lead to water penetration in the basement. Recommend that the diverter is reattached to the downspout.

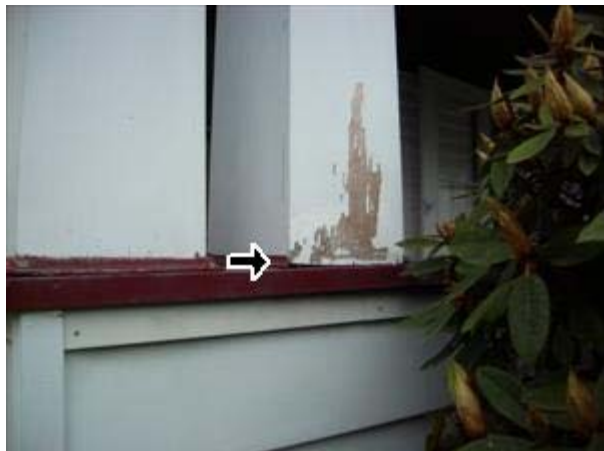
2.0 Picture 1

(1) Cracked and peeled paint and missing trim was observed on the post near the NW corner of the home

(Picture 1) . This may allow water to penetrate the wood. Recommend that this area is repaired and painted.

(1) Cracked and peeled paint and missing trim was observed on the post near the NW corner of the home (Picture 1) . This may allow water to penetrate the wood. Recommend that this area is repaired and painted.
-

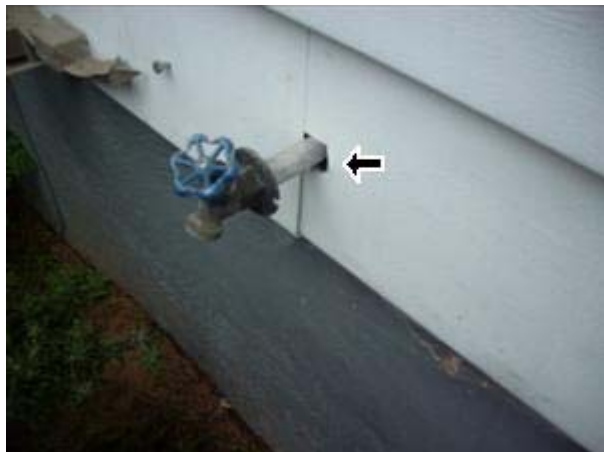
2.0 Picture 2

(2) A gap was observed where a hose bib comes through the wall (Picture 2) . Water and insect pests may enter through this gap. Recommend that this gap is sealed with a quality caulk.

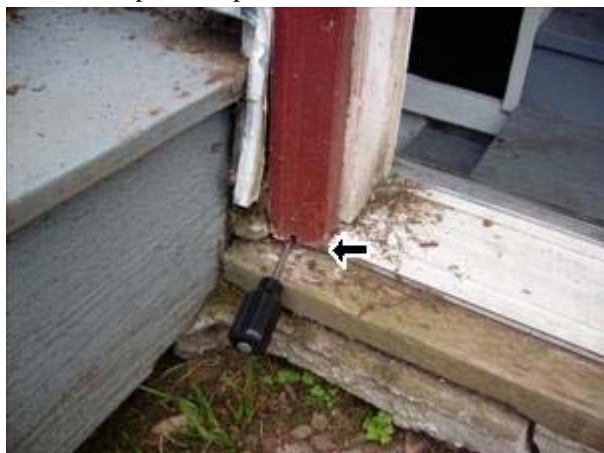
2.1 Picture 1

An area of rot was observed in the door trim at the basement door (Picture 1) . Recommend that a licensed contractor repair or replace this rotted wood.

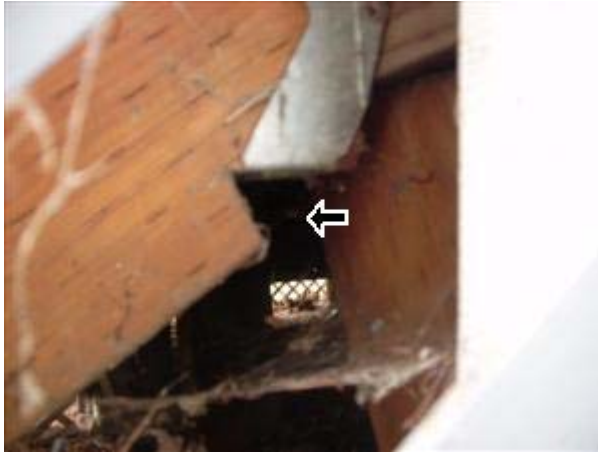
2.3 Picture 1

(2) The stair stringers on the front porch were notched to accommodate a joist hanger (Picture 1) . The stairs appear structurally sound, however the notches may reduce the strength of the stringers. Monitor the visible stringers for cracking. Monitor the stairs for sagging. Repair the stringers as necessary.

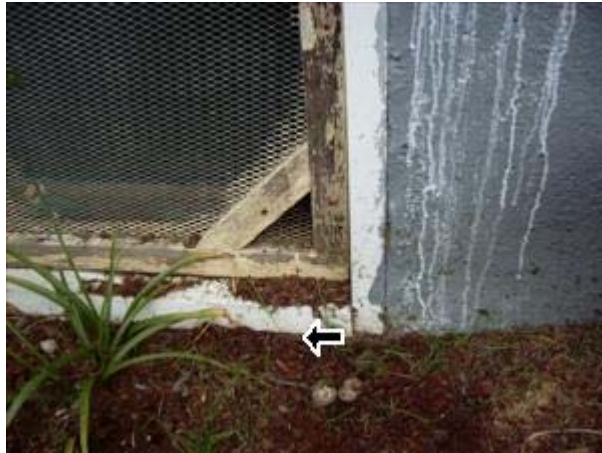
2.4 Picture 1

(2) The ground was observed in contact with the siding and the basement window sills (Picture 1) at several locations around the home. This may allow water or insect pests to enter the home. Recommend that all soil is graded 4-6" below the siding and window trim.

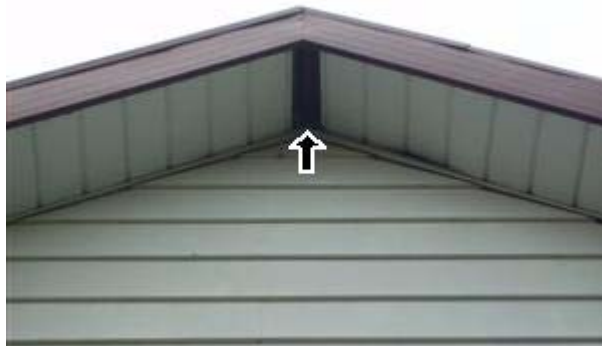
2.5 Picture 1

A small section of soffit is missing near the peak at the front of the home (Picture 1) . Insect or animal pests may nest in the opening. Recommend that the area is repaired.

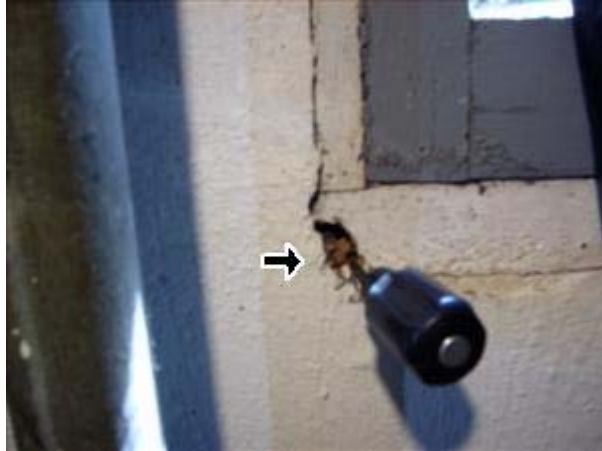
4.0 Picture 1

(1) Some wood rot was observed in the window sill of the basement windows (Picture 1). Wood rot can attract insect pests and may spread to adjacent wood structures. Recommend that a licensed contractor repair all rotted areas of the the basement windows.

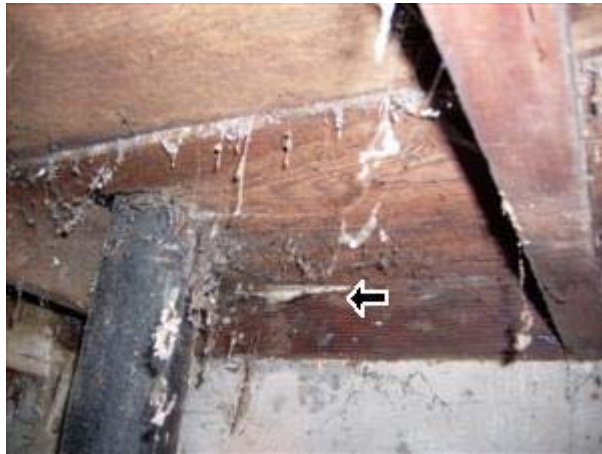
4.0 Picture 2

(2) Fungus growth and wood rot was observed in the basement below the basement stairs (Pic 2). This is indicative of excess moisture and contact with the concrete. Recommend a licensed contractor replace all rotted wood as needed.

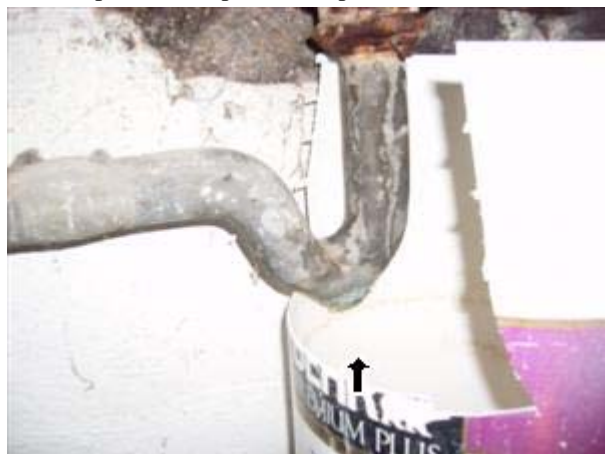
5.0 Picture 1

- (1) An active leak was observed at the drain under the basement utility sink (Picture 1) . Recommend a licensed plumber inspect and repair this drain line as needed.

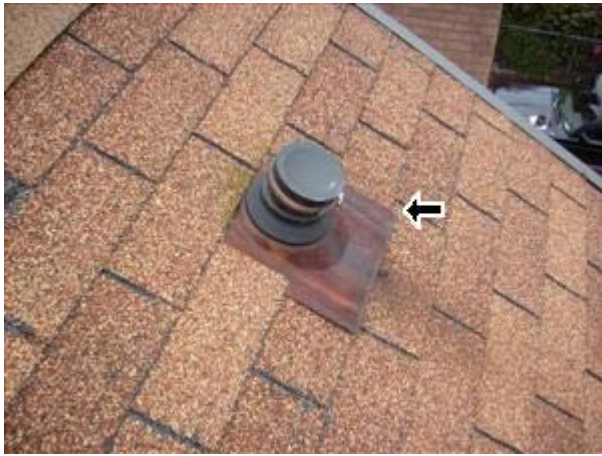
5.0 Picture 2

- (2) The main plumbing stack vent (Picture 2) and a small vent are capped. These vents must be open to the air to allow proper function of the plumbing waste lines. The main stack did not extend above the roof very far to properly vent sewer gases. Recommend a licensed plumber inspect and remove the caps and extend the main stack vent.

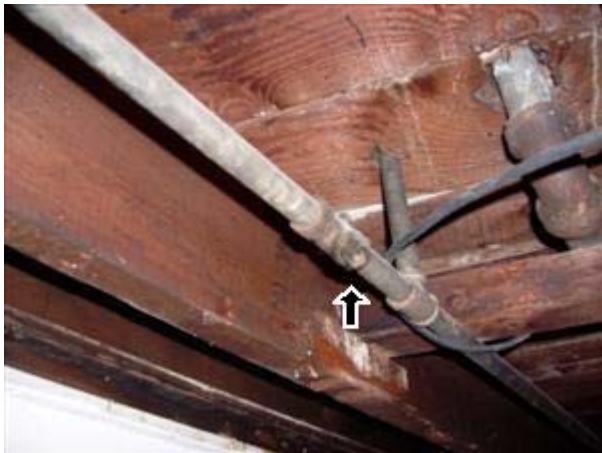
5.1 Picture 1

An active leak was observed in the plumbing near the NE corner of the basement (Picture 1) . Recommend a licensed plumber repair this leak.

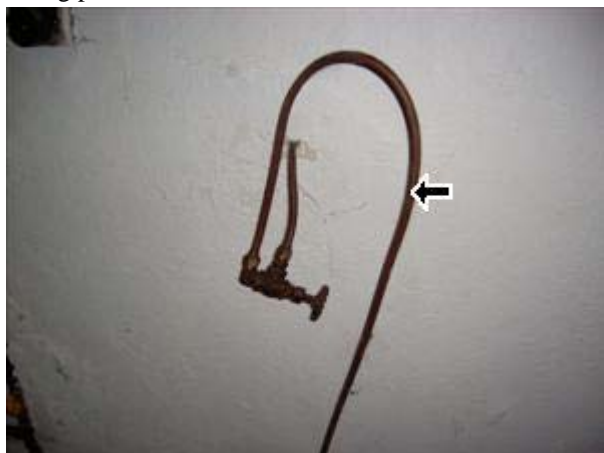
5.4 Picture 1

Old oil supply lines were observed in the basement near the south foundation wall(Picture 1) . This may indicate the existence of an underground oil storage tank. Recommend that a licensed tank specialist inspect the

property for an underground tank. The tank and copper supply lines should be properly decommissioned and soil testing performed to ensure no contamination has occurred.

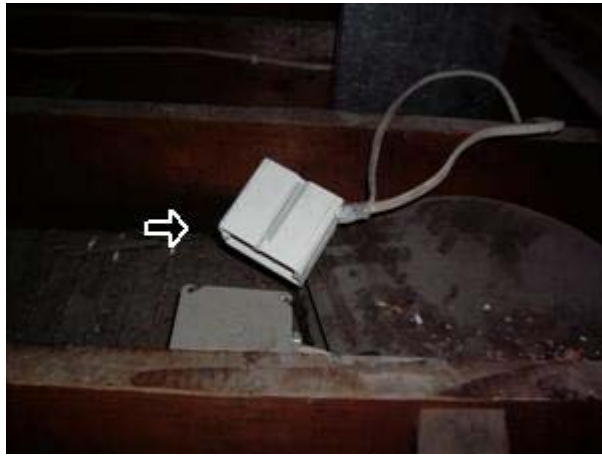
6.2 Picture 1

(1) A loose junction box without a cover was observed in the south attic space (Picture 1) . All junction boxes should be secured to the framing and should have a properly installed cover. Recommend that a licensed electrician secure and cover this box.

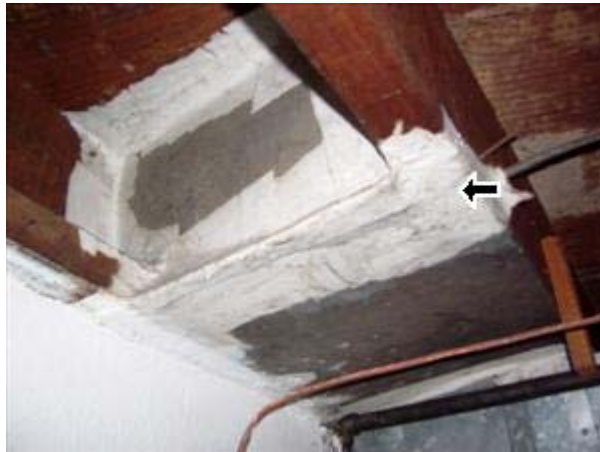
7.3 Picture 1

(1) The white tape on the ductwork is possible asbestos tape (Picture 1) . Asbestos is a known carcinogen. Many expert recommend leaving the asbestos tape in place and encapsulating it under paint. For more information about asbestos, visit www.epa.gov/asbestos.

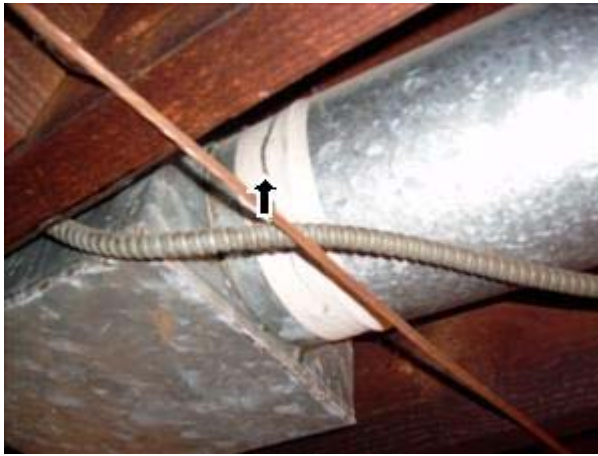
7.3 Picture 2

(2) A gap in the tape sealing a duct was observed near the south side of the basement (Picture 2) . This may reduce the efficiency of the heating system. Recommend installing new duct tape over the old tape (possible asbestos).

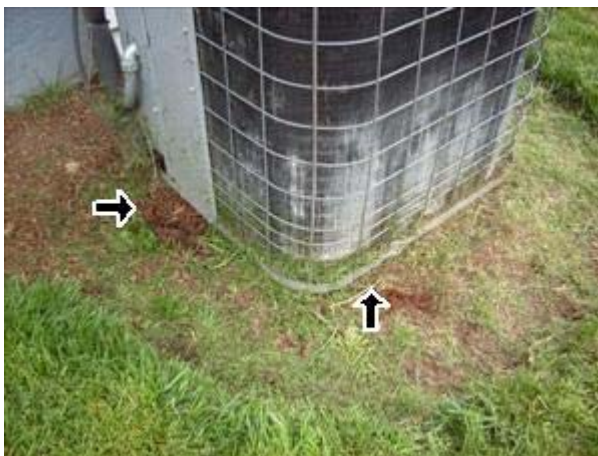
7.8 Picture 1

(1) Debris and bar dust was observed on the AC pad and in contact with the cooling fins of the AC unit (Picture 1) . This debris can reduce the efficiency and life of the AC system. Recommend that all debris is kept clear of the AC unit.

(2) Some deterioration of the cooling fins was observed on the AC unit (Picture 1) . This may be from pet urine. Recommend that the power is disconnected from the AC unit and the fins are carefully rinsed with cool

water. An HVAC specialist should inspect the AC unit to ensure the damage is not causing leakage of coolant.

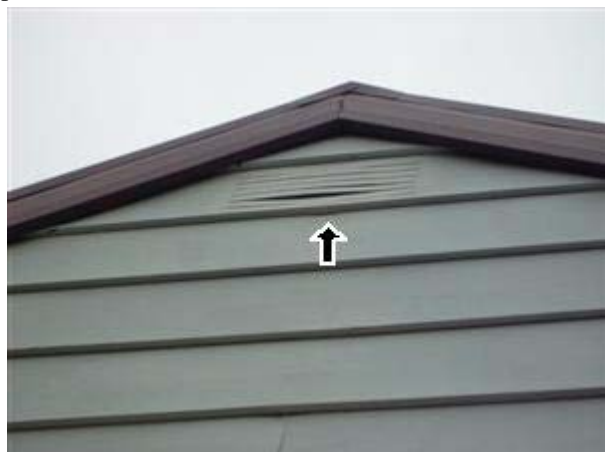
8.3 Picture 1

8.3 VENTILATION OF ATTIC AND FOUNDATION AREAS
Ventilation: Roof vents, Gable vents, Soffit Vents
Comments:
The ventilation of the attic space may be inadequate. The roof and soffit vents were placed to vent an open attic space. The attic space is now converted to a living space. Insulation is in the rafters and in contact with the roof sheathing. The gable vent on the east side of the home was covered and small slits that appear inadequate have been cut in the siding (Picture 1) . Recommend monitoring the attic spaces and the finished ceiling in the upstairs room for evidence of moisture issues (staining, mold, mildew). Contact a ventilation specialists if problems are observed.

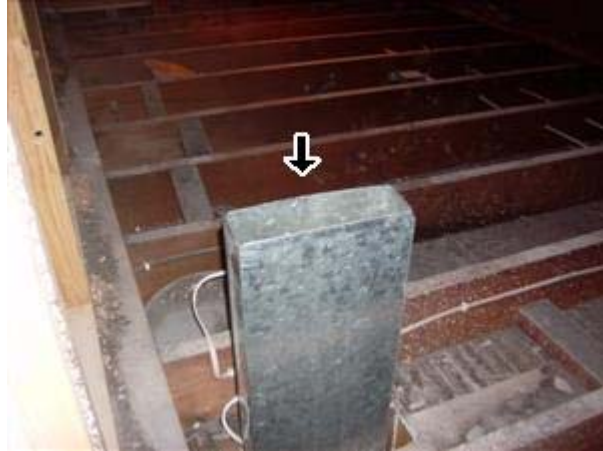
8.4 Picture 1

(1) The kitchen hood fan vents into the south attic space (Picture 1). This can lead to excessive moisture in the attic. Recommend a licensed contractor extend this duct through the roof surface.

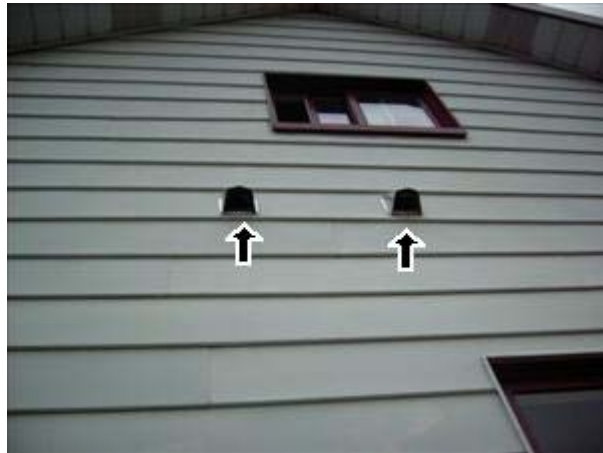
8.4 Picture 2

(2) The ventilation exhaust for the bathroom fan did not have a grate or flapper installed (Picture 2) . Bird or insect pests may enter the home at these vents. Recommend installation of a grate or flapper to keep pests out.
